Critical conditions (flow obstacles) in torrents

DI Felix Schiestl DI Thomas Schaller

- Legal base in Austria
- Torrent inspection
- Riparian vegetation driftwood
- dangerous depositions

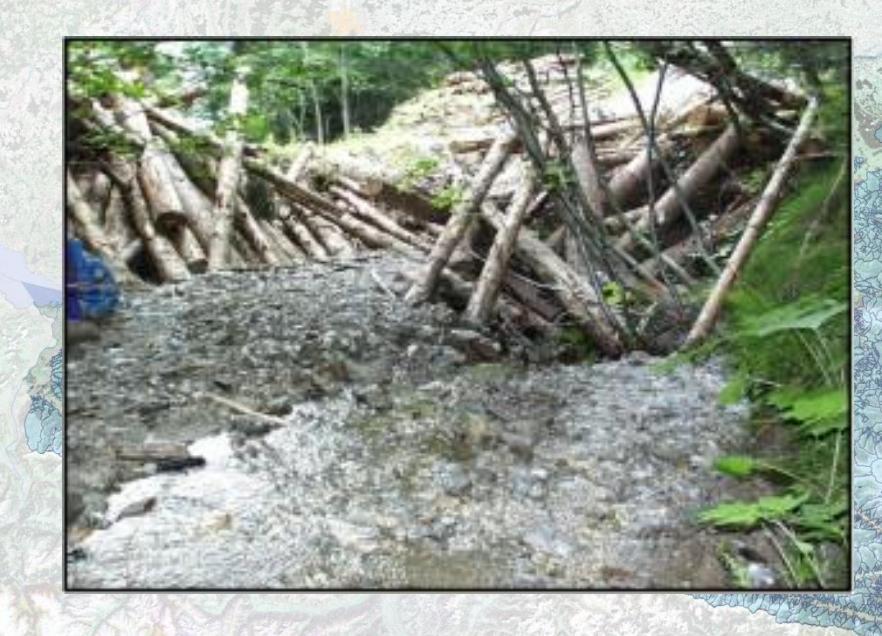
1.discharge obstacles: dangerous deflection or damming in the event of flooding

2.objects that can be removed

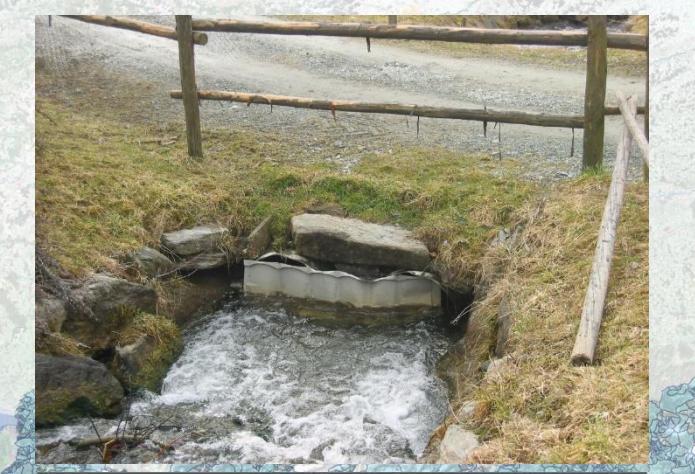
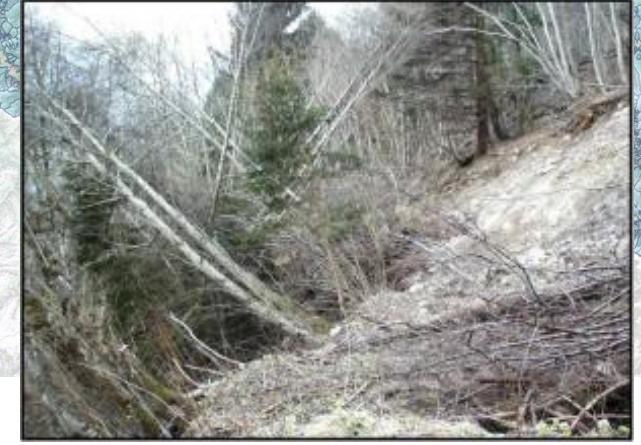
3.artificial or naturally occurring changes to the normal flow of water

4.objects at risk of slipping or falling

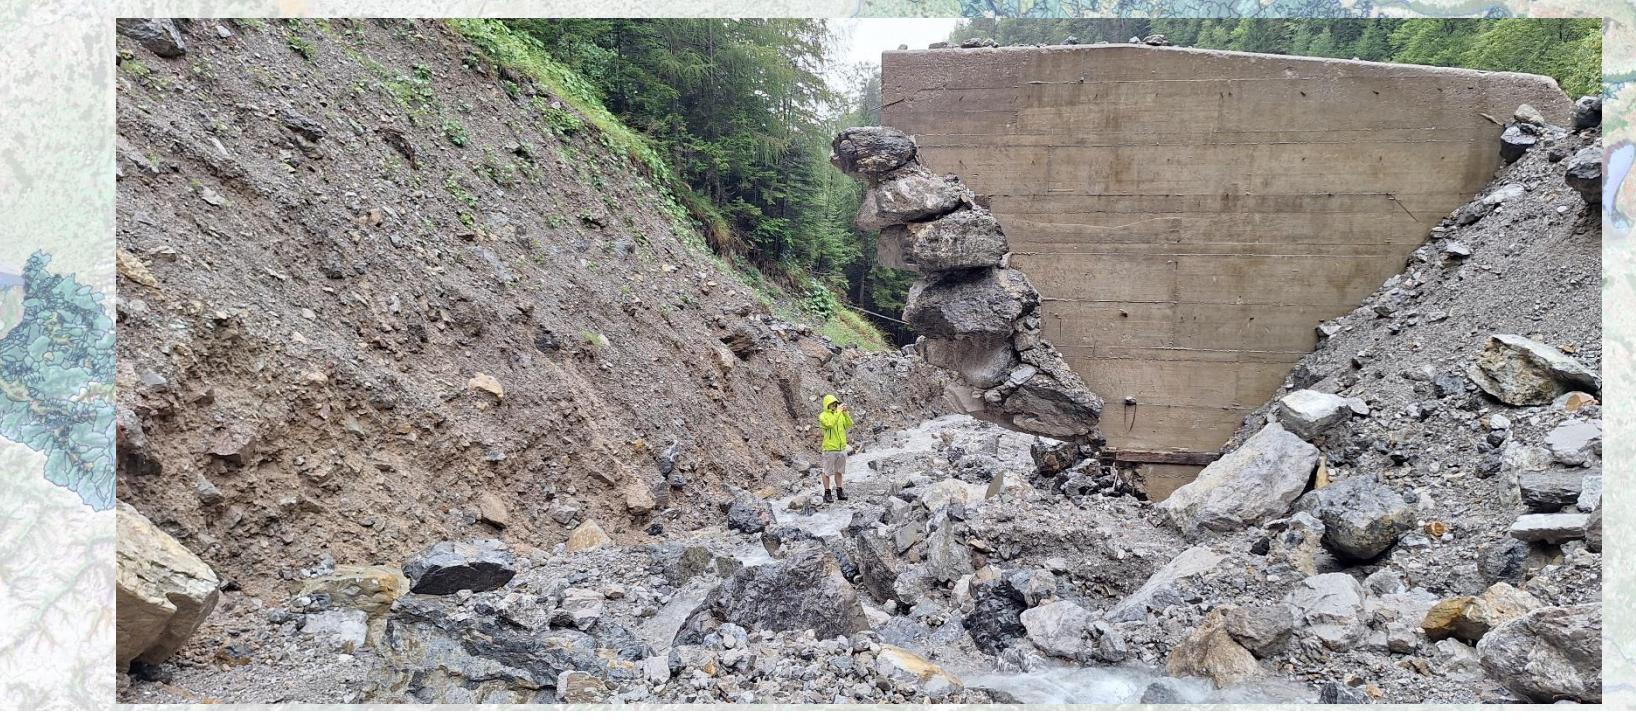
5. obvious damage to hydraulic defence structures

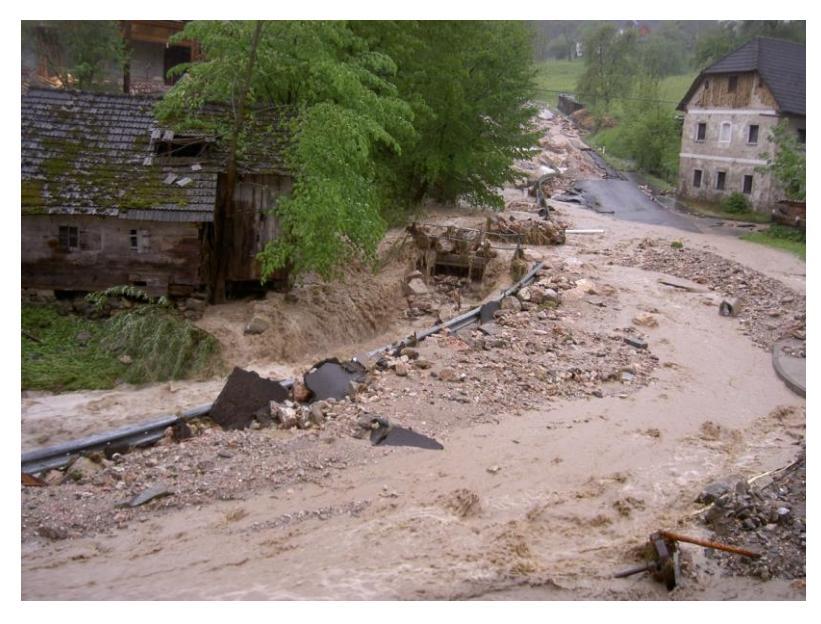
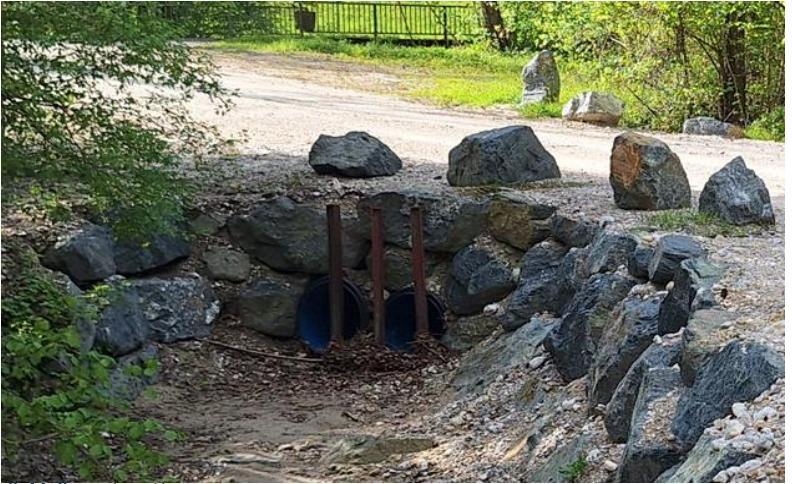
Deposits and reduction of the discharge profile

The discharge profile of a torrent has a too low discharge capacity during a flood event, so that overflowing can occur and the stream breaks out of its original streambed

Temporary blockage of the drainage cross-section of a torrent by driftwood, debris or other material (also manmade objects like cars, silo bales etc.).

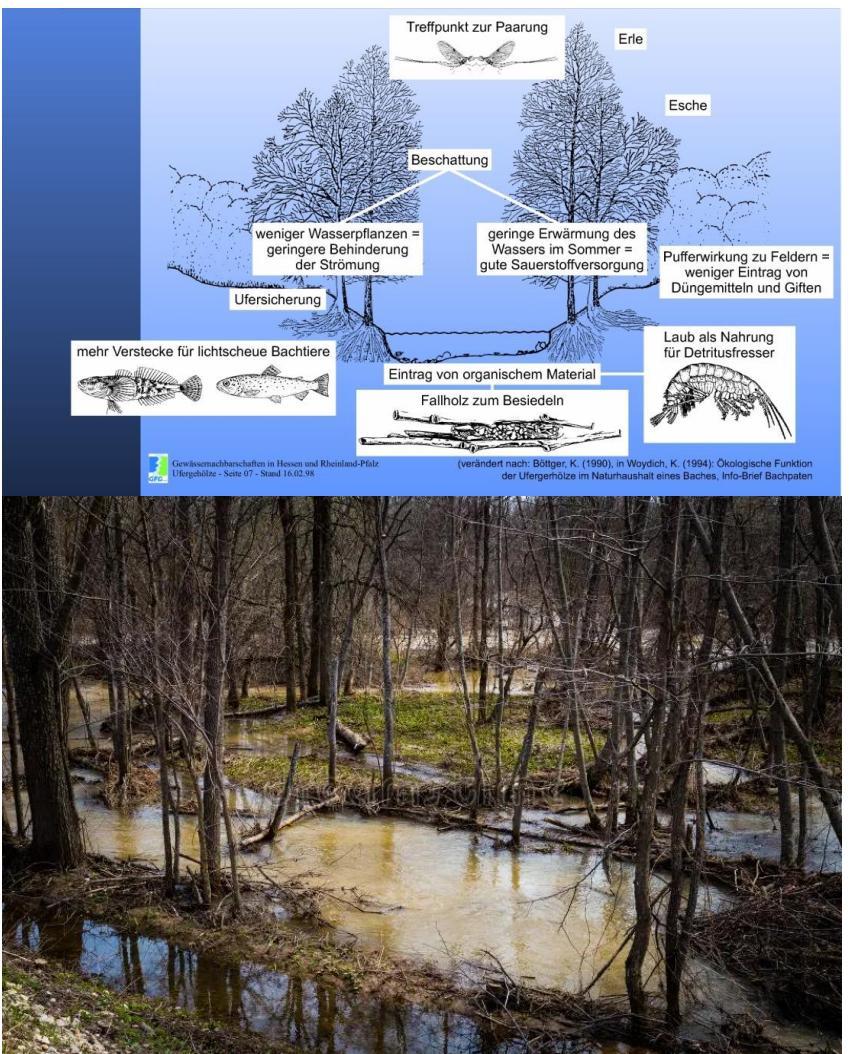
Ecological importance: creates habitat for numerous animal and plant species. Also supports the natural flow dynamics and morphological development of watercourses.

Protective effect: the rooting of the banks and the above-ground plants protect the banks against erosion. In wider sections of the stream, debris and driftwood can be filtered out by the forest.

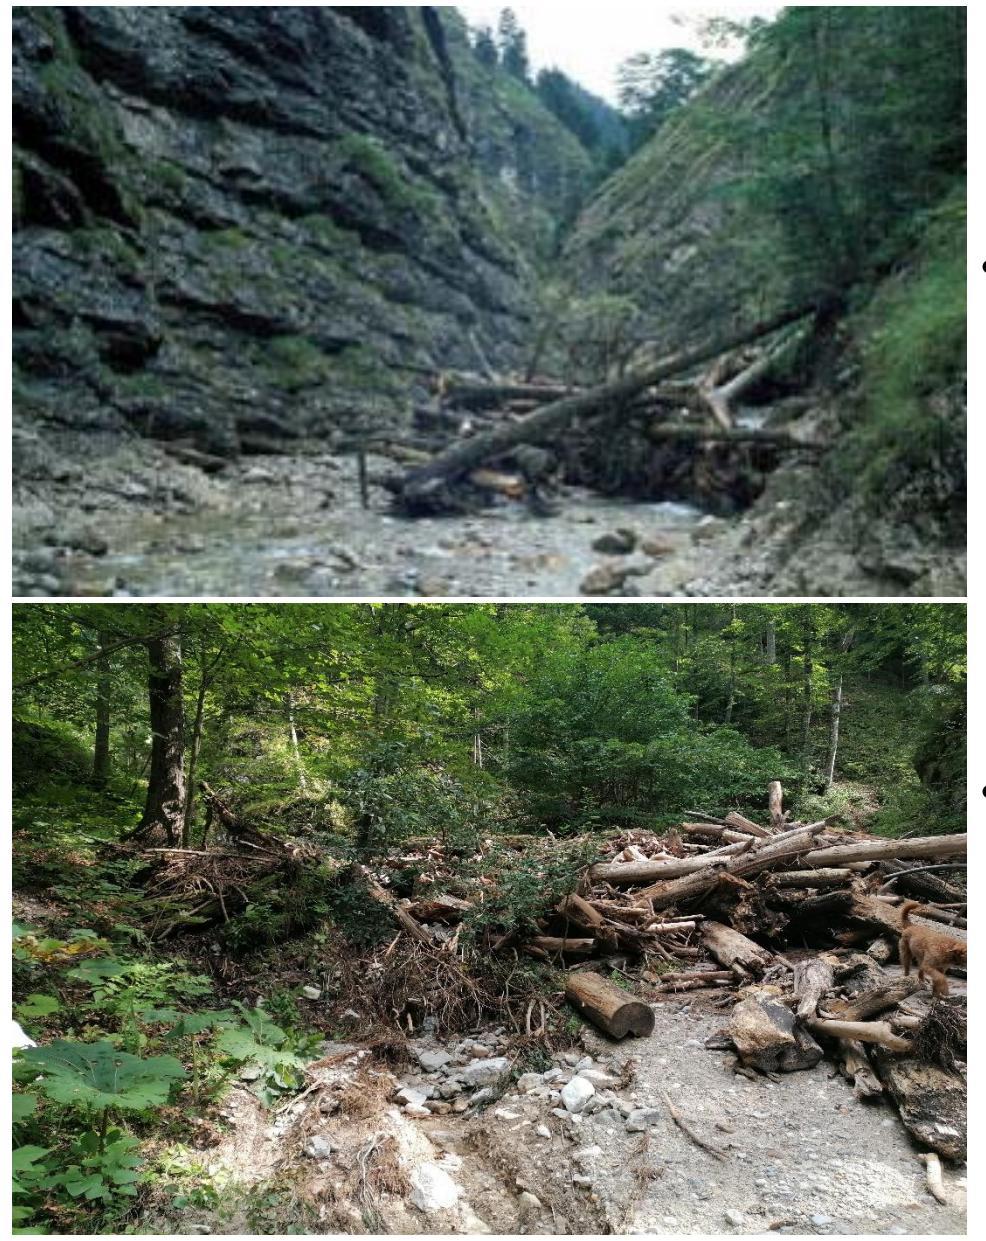
- is a collective term for 'deadwood' (i.e. the wood already lying in the stream) and green wood that is freshly carried in during a flood event
- However, driftwood also poses a risk, particularly for urban areas, due to clogging or destructive effects.

- Clogging lead to the accumulation of water and debris runoff and builts up instable dams. In the event of a dam (clogging)
 breach, the formation of debris flows and an increase in the discharge peak can be caused.
- Trees that slide down the slope or fall into the channel due to windthrow or slope failure can dam up water during heavy rainfall, break open and trigger a runoff surge that far exceeds the normal flood discharge.

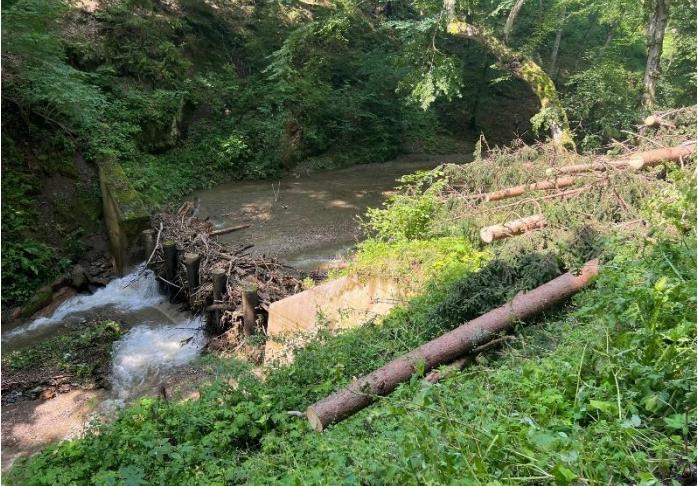
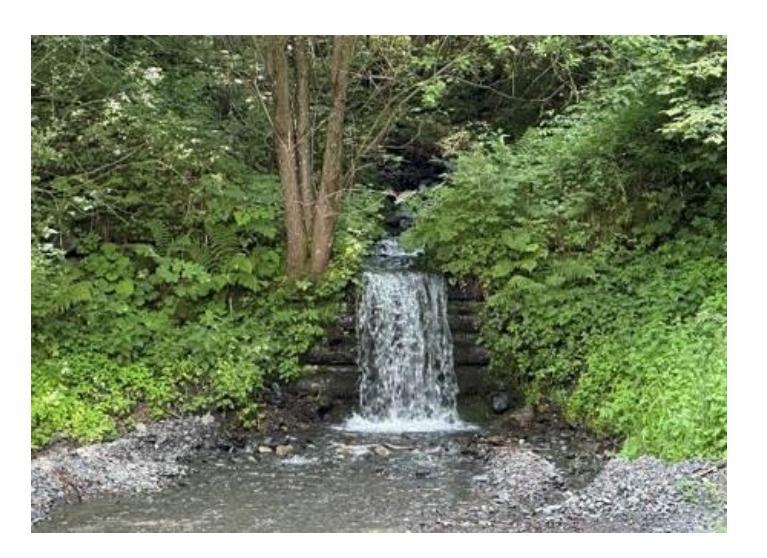
Impairment of the function of protective structures (e.g. blockage of the bottom outlet, etc.). Partial or complete blockage of open-crown bedload retention barriers and flood retention structures

Trees growing into the drainage profile can lead to backwater and stream bursts and subsequent inundation.

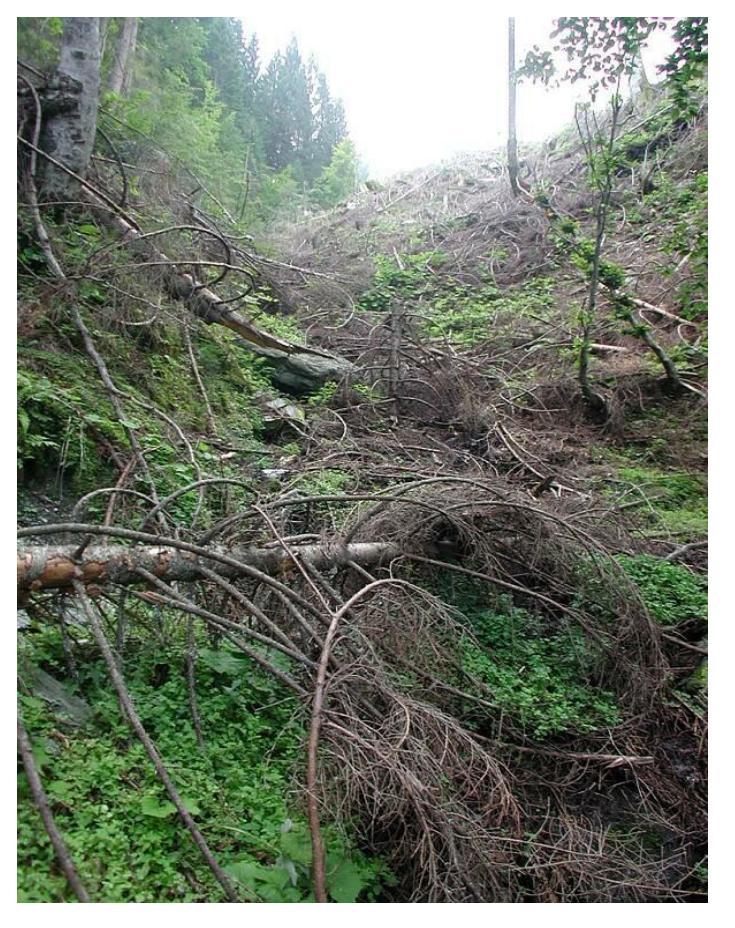
Dangerous Wood Depostion – with Causer! Deposits after logging

After forestry work or road construction, wood, pieces of treetop or branch material often remains in the area of the channels. This slash is a frequent and often underestimated source of danger. When cable cranes are used with processors, the branch material is often stored in large branch piles under the road. This is a real source of danger near torrential channels.

Felled wood can be mobilised here by heavy rain and slope failure cause blockages at stream crossings or similar.

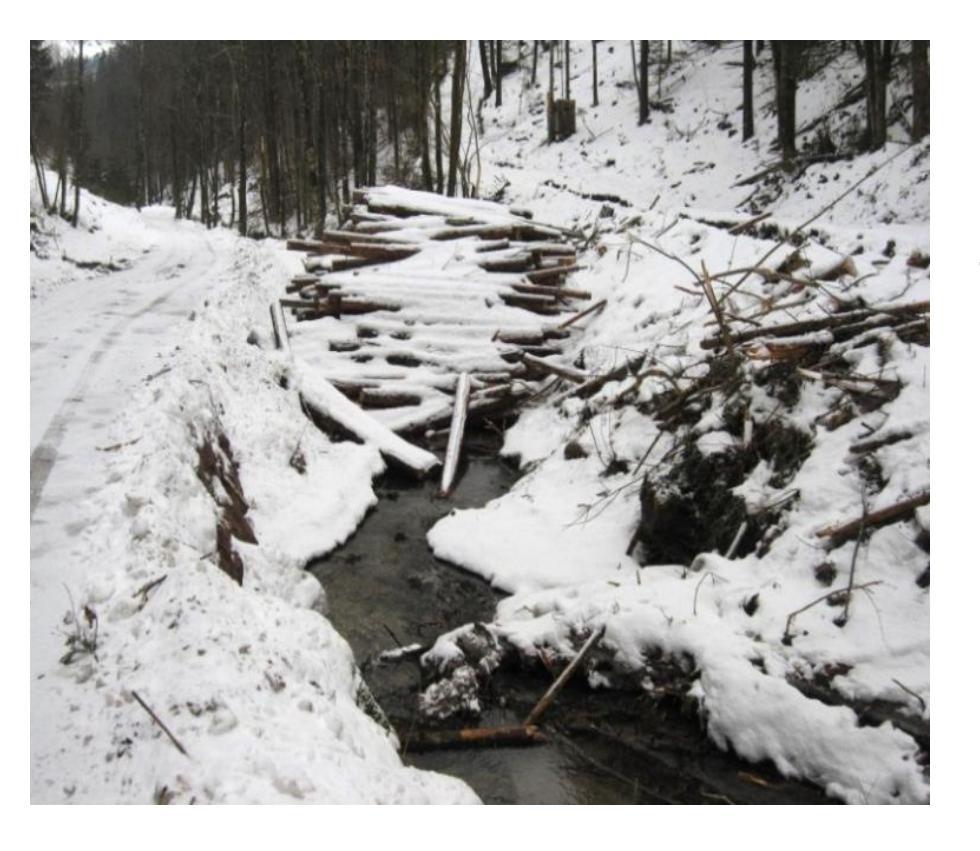
Dangerous Wood Depostion – with Causer! Wood storage

In the course of utilisation, wood (logs, poles, whole trees) is stored in the floodplain.

Storage can be 'temporary' (max. 1 week in direct connection with felling work) or 'permanent' (storage of wood chips for drying, wet storage after beetle infestation...)

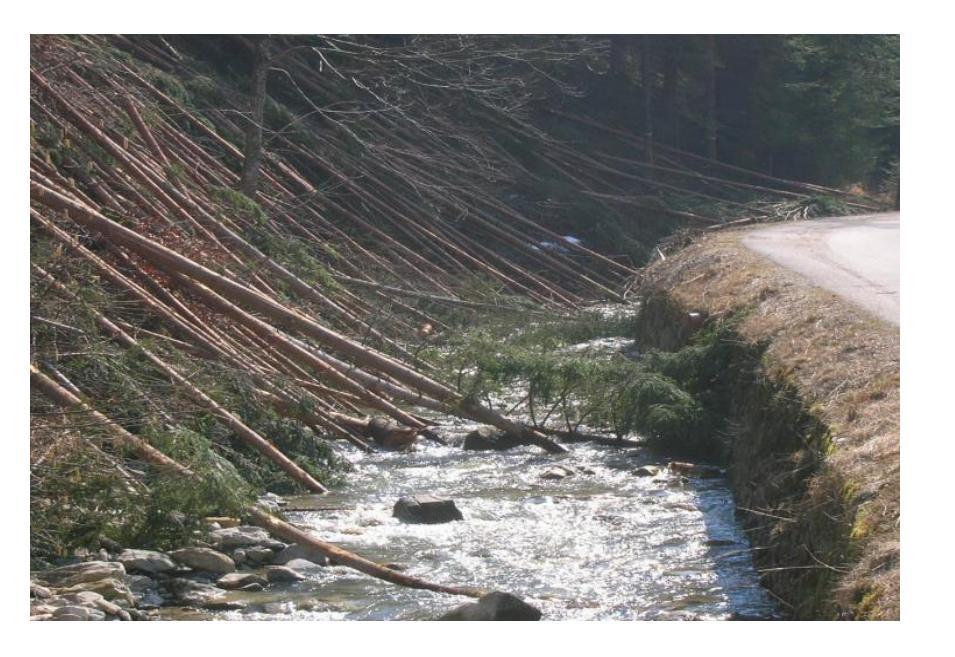
If the flow profile is already so severely affected by the occurrence of a small (annual) flood event that a creek breakout and the associated consequential damage is to be expected, and the weather forecast predicts heavy rain for the coming days, the felled wood is to be immediately removed by the person responsible.

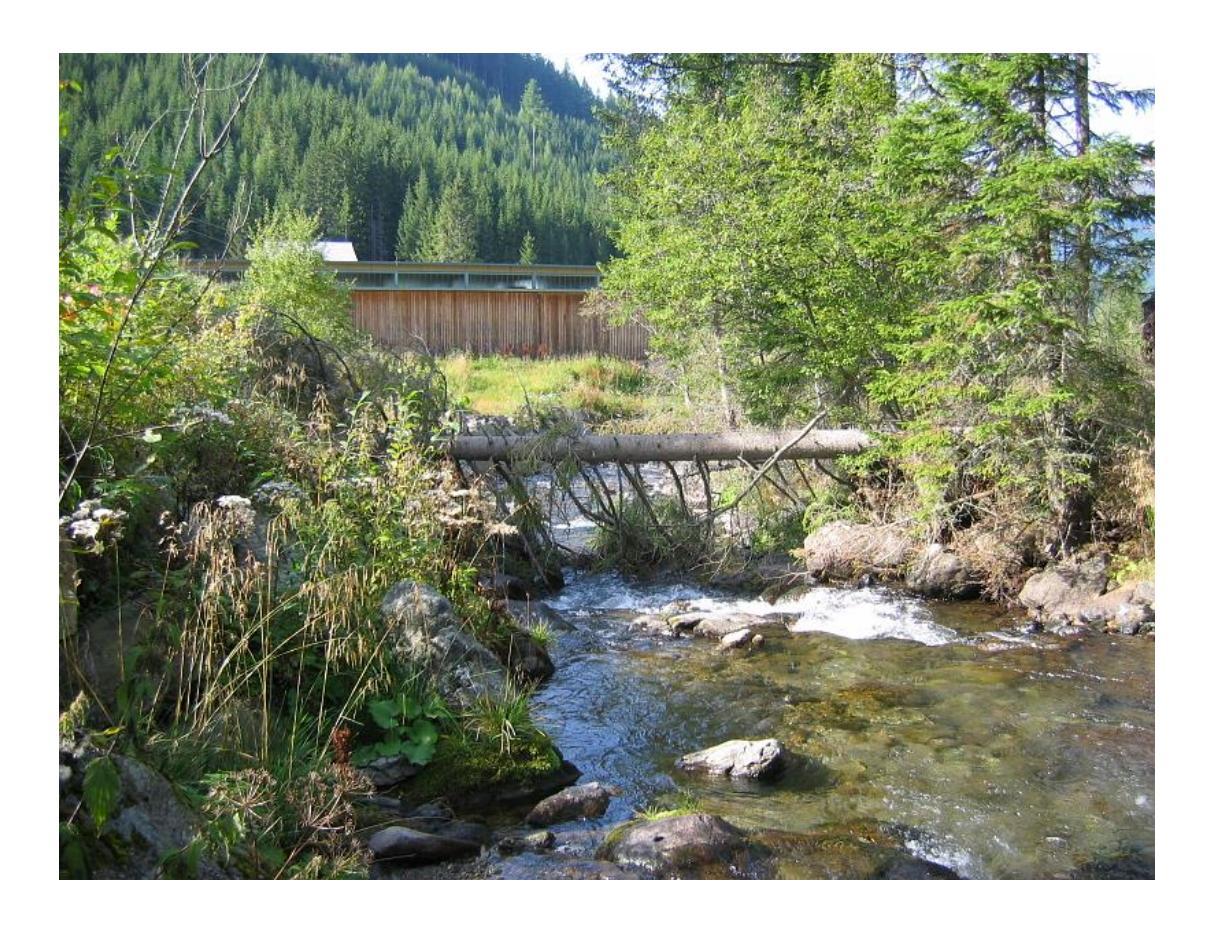
Potential reasons:

- 1. Avalanche
- 2. Snow break
- 3. Wind throw
- 4. Bank failure or lateral landslide

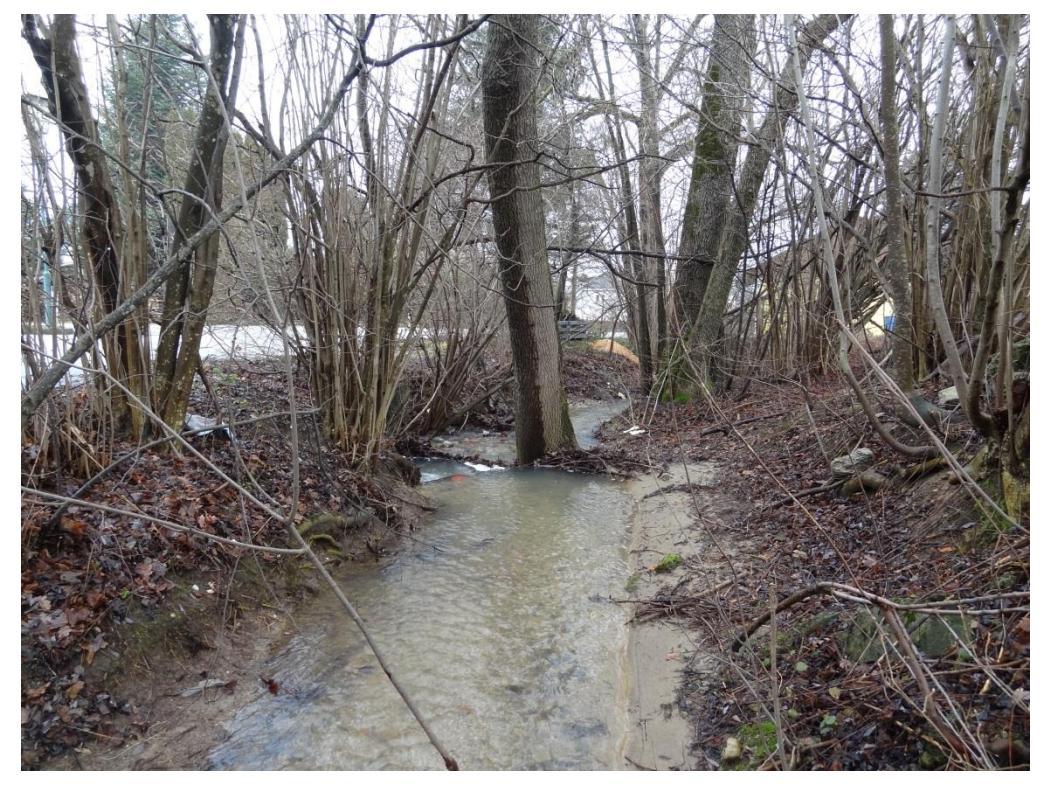
Vegetation as an obstacle to discharge Obstacle / potential clogging

Especially in the case of small and medium-sized torrents, the flow cross-section of the channel can be severely restricted by unfavourable bank vegetation, so that in the event of heavy rainfall, a direct stream outburst and consequent flooding can be caused or debris jams can be more easily enabled.

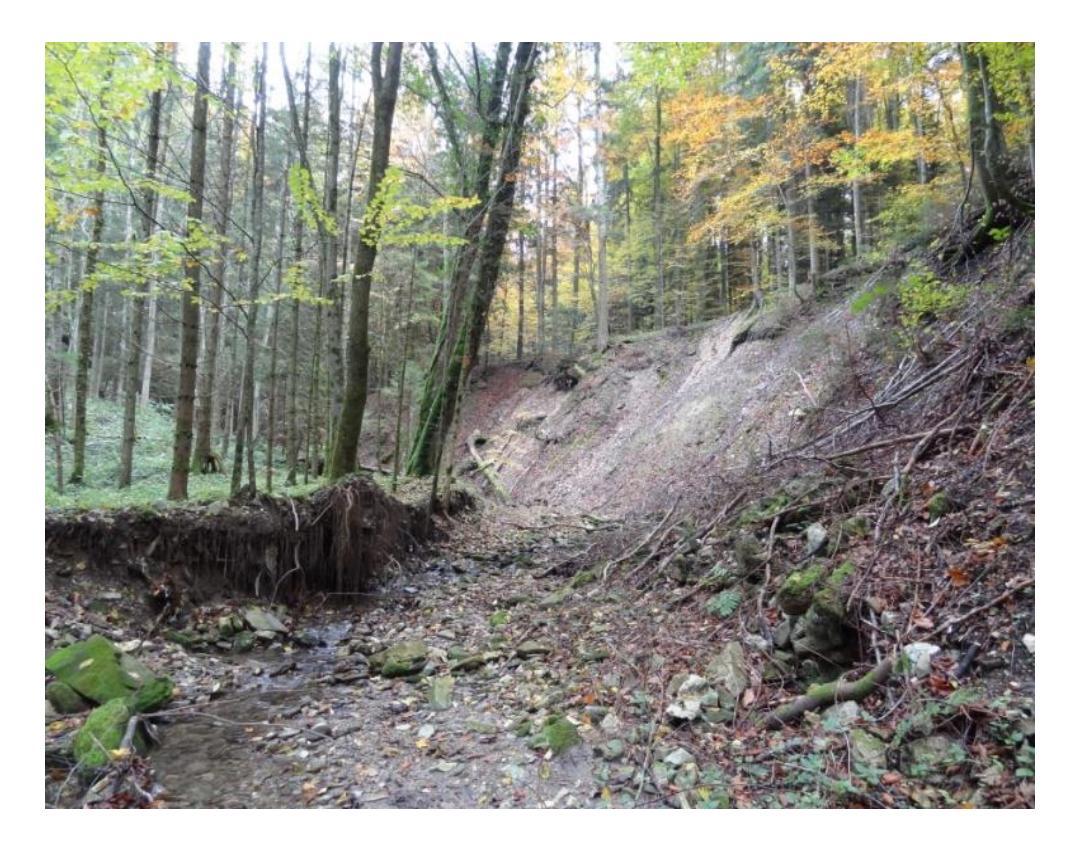
Unstable growth (slopes) / impending entry of driftwood

If instable trees, that threaten to fall into the stream and slide down, are found during the inspection, the landowner/neighbour should arrange for their preventive removal.

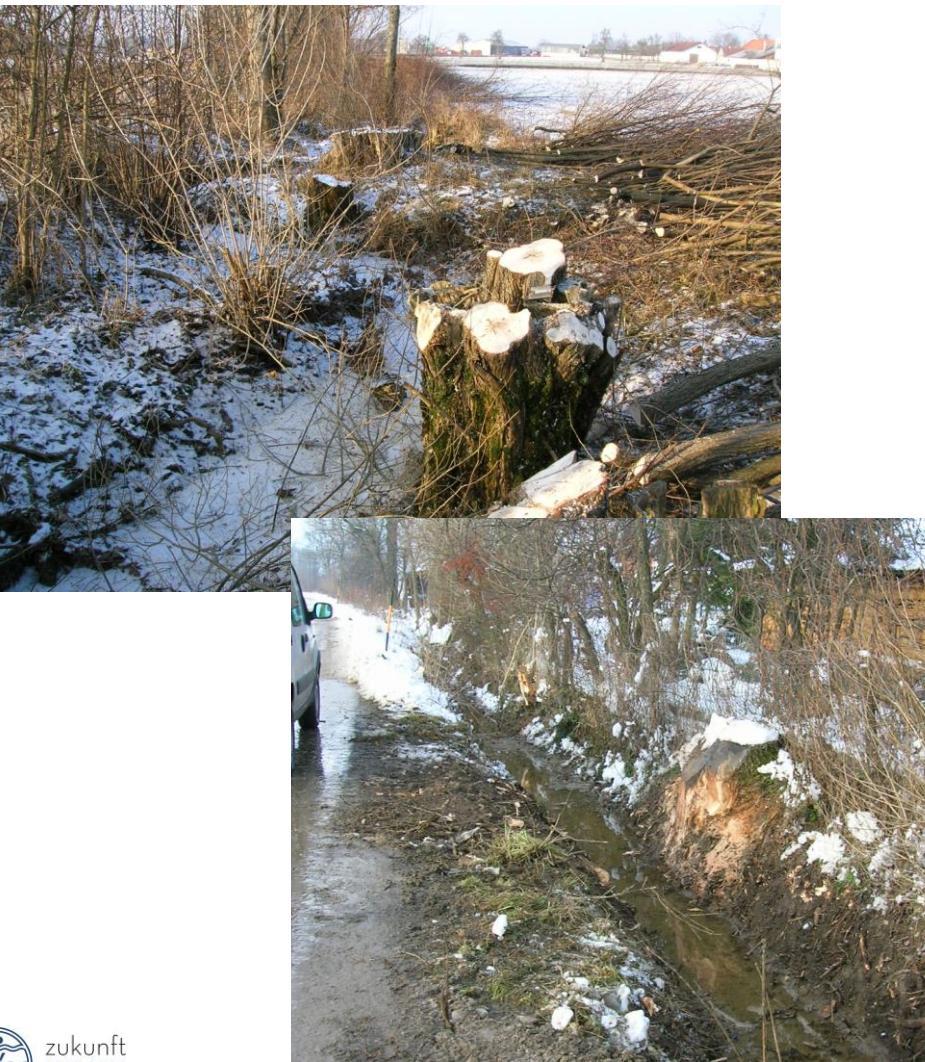
- New vegetation on the bank must be ensured (cane shoots etc.)
- 2. Trees growing directly in the stream bed should ideally be cleared.
- 3. Remaining rootstocks with stalks can still have the same negative effect.
- If it can be assumed that the rootstock that would normally remain can also slip into the stream bed, it should be cleared.

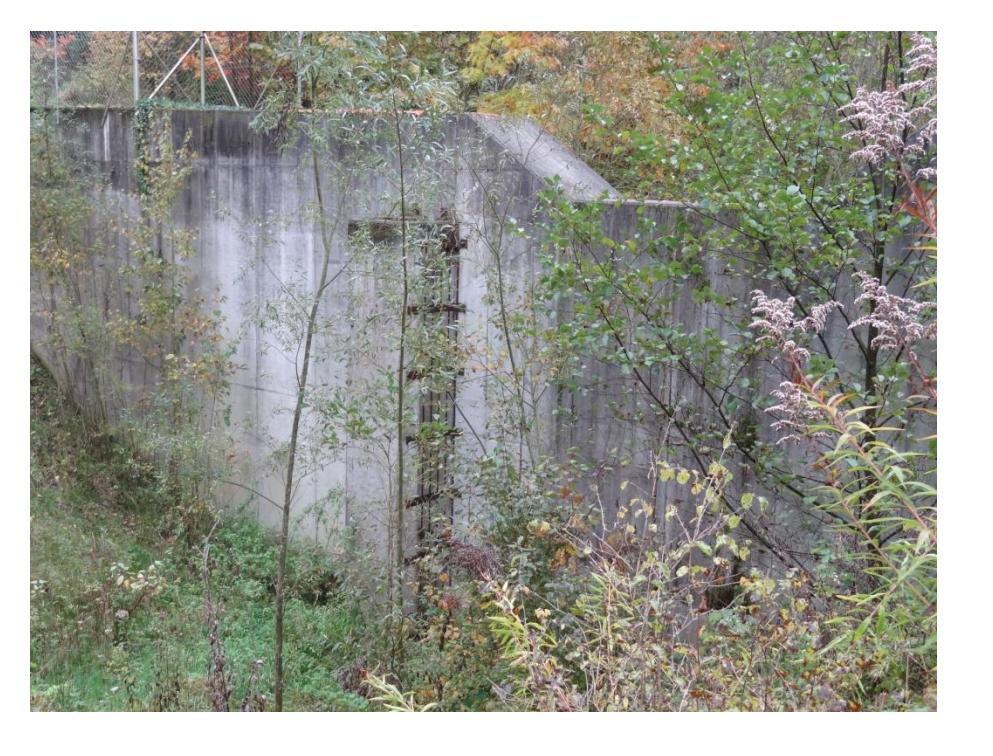
An expert for torrent and avalanche control has to assess whether the vegetation is permissible.

- 1. Plant cover consisting of grasses and low, flexible shrubs increases the erosion resistance of slopes.
- 2. Pay attention to local scour holes that attack the dam body. This results in open areas in the dam which are quickly further eroded.
- 3. When trees with strong roots die, current channels can develop in place of the rotted roots.
- 4. Forested retention areas have less retention volume and can become clogged.

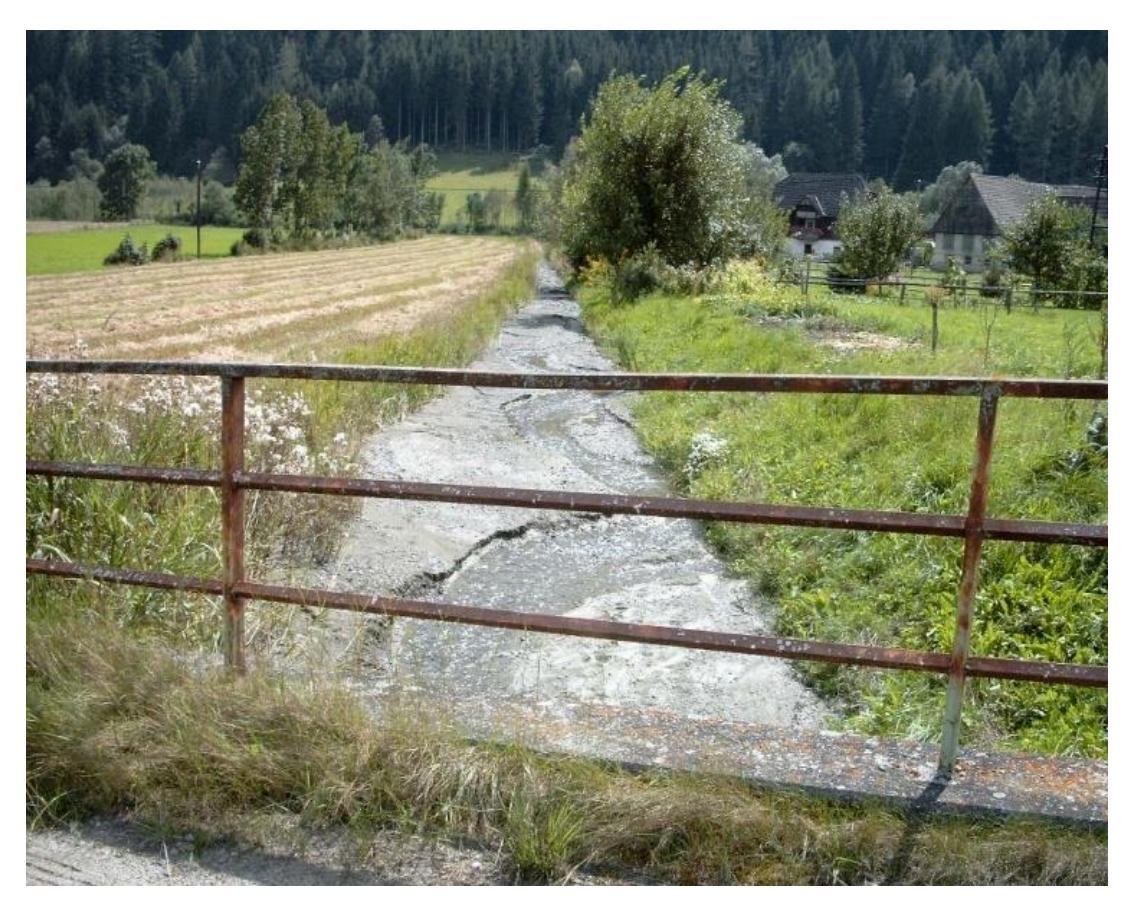
Bedload transport is a key characteristic of mountain torrents.

Deposits in and outside the torrent often result in sedimentation with farreaching consequences. A channel cross-section that is sufficiently large in and of itself can thus very quickly be overloaded, causing extensive damage. Sedimentation is to be considered critical, especially at stream crossings.

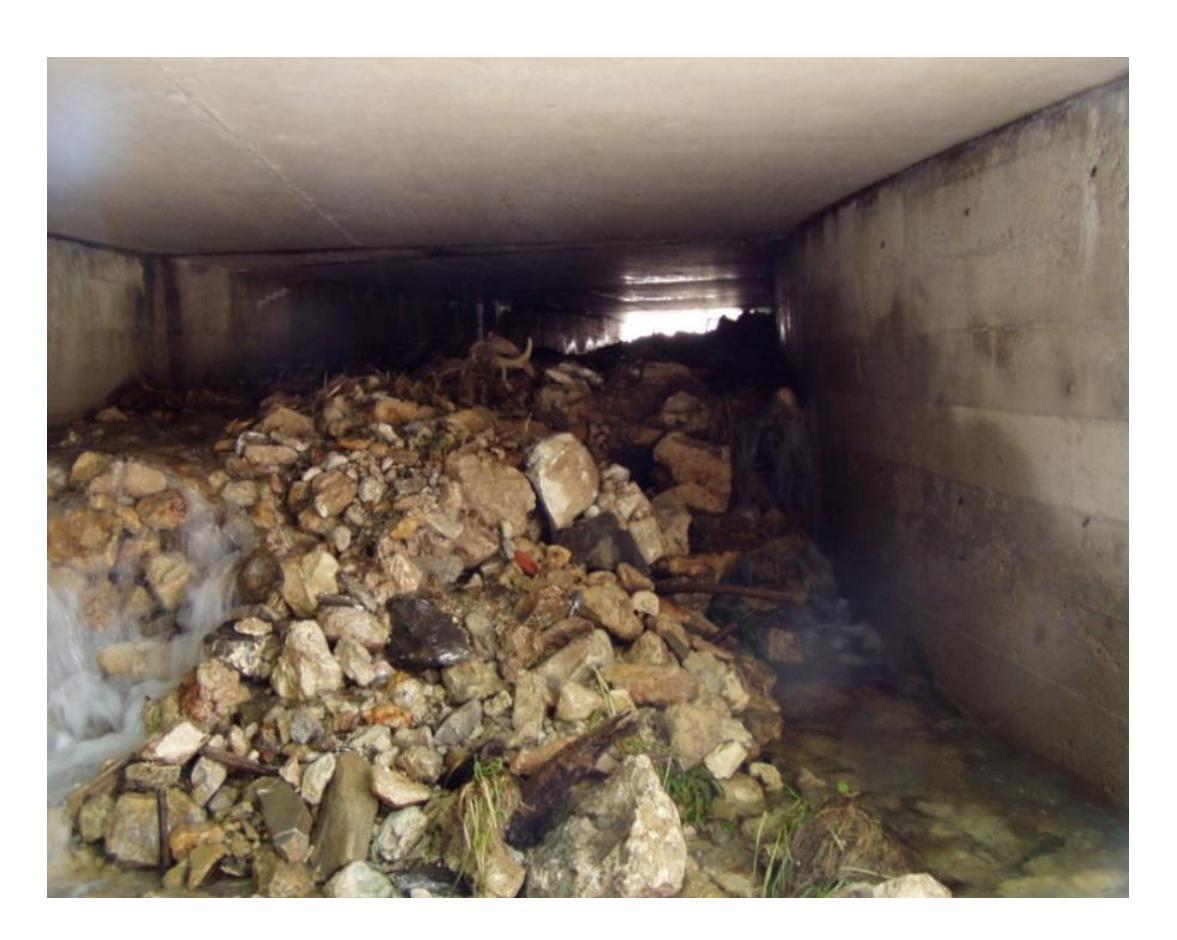
If the bedload accumulation/deposition occurs in a regulated river section or near bridges, the consensus applicant (municipality, water cooperative, road maintenance authority, etc.) is generally responsible for maintaining the functionality of the approved structures.

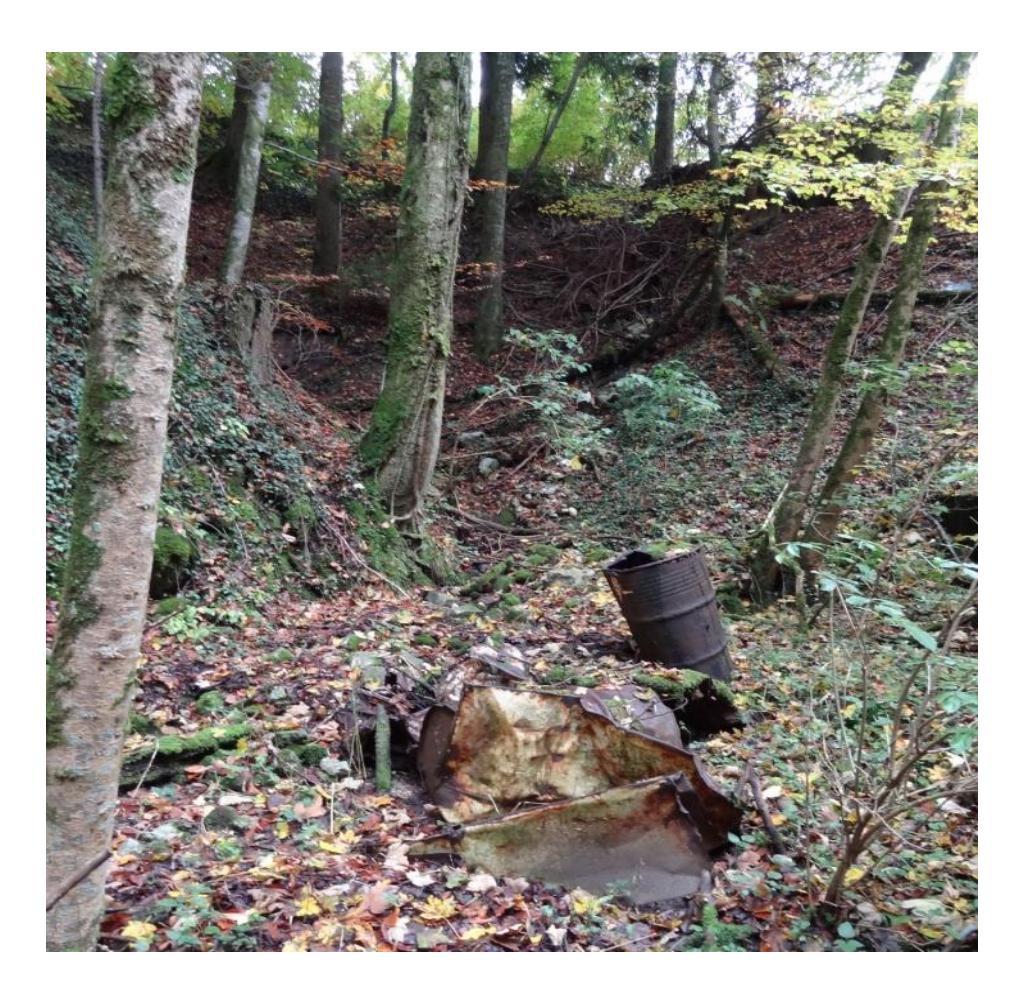
Waste (pollution)

can also have a negative impact on runoff (erosion of the banks due to warping of the stream, debris jams, etc.) and also constitute a violation of the Forestry Act and the Waste Management Act.

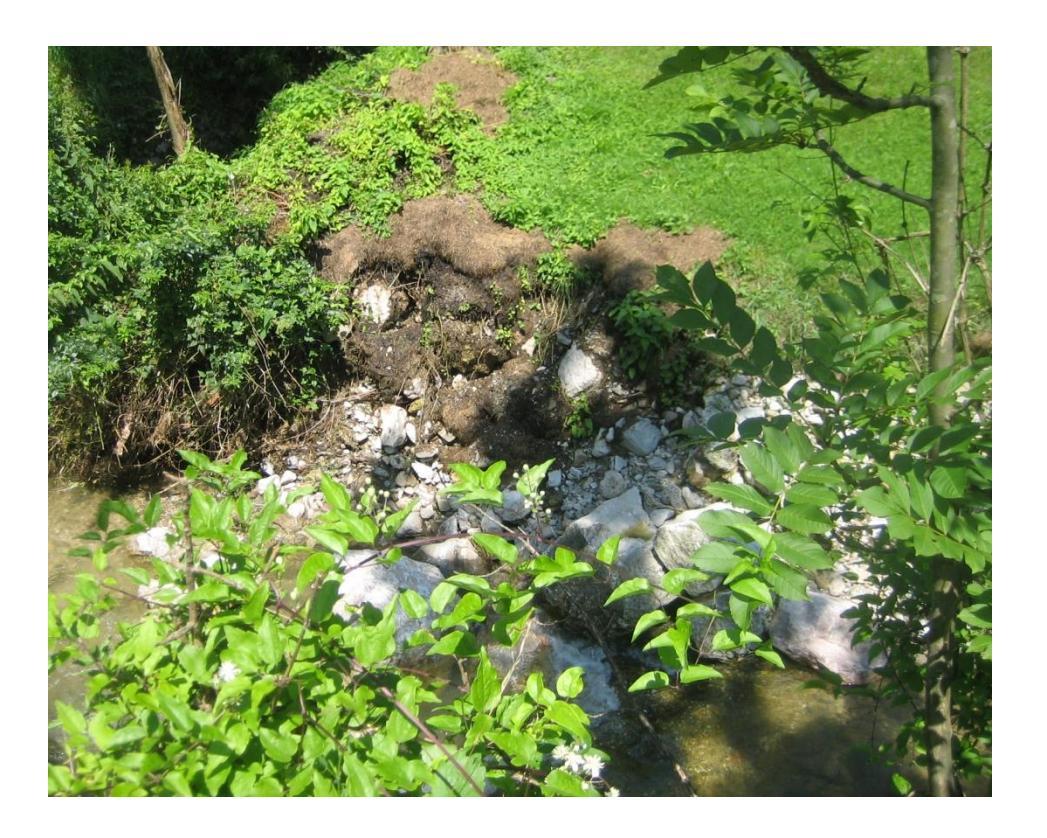
Shrub and green waste

Shrub and, in particular, green waste do not usually pose an immediate risk of flooding, but they can also have negative consequences:

- Humic acids can damage riparian vegetation by acidification, preventing plants from growing and making the bank more susceptible to erosion.
- Clogging of narrow points such as pipework etc.

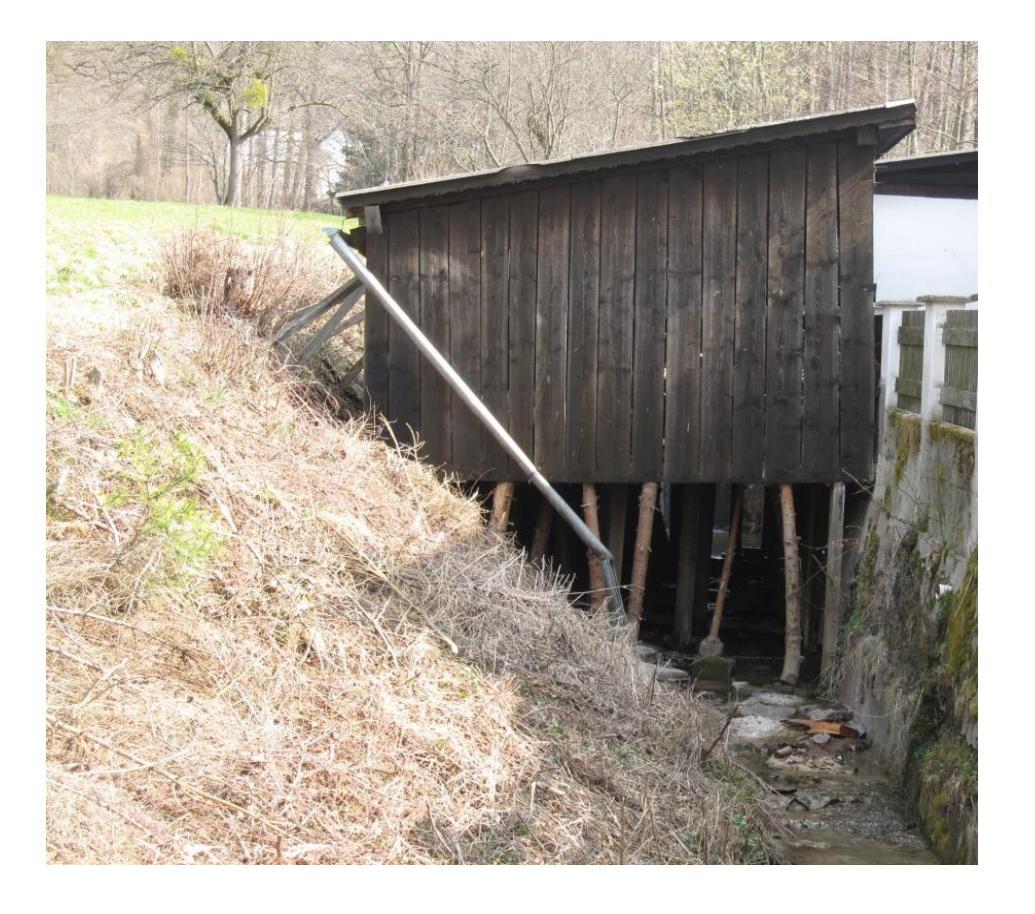
Obstruction to streambed Built-in structures

Artificial structures and built-over secttion can also cause extensive damage if they are improperly constructed or poorly maintained

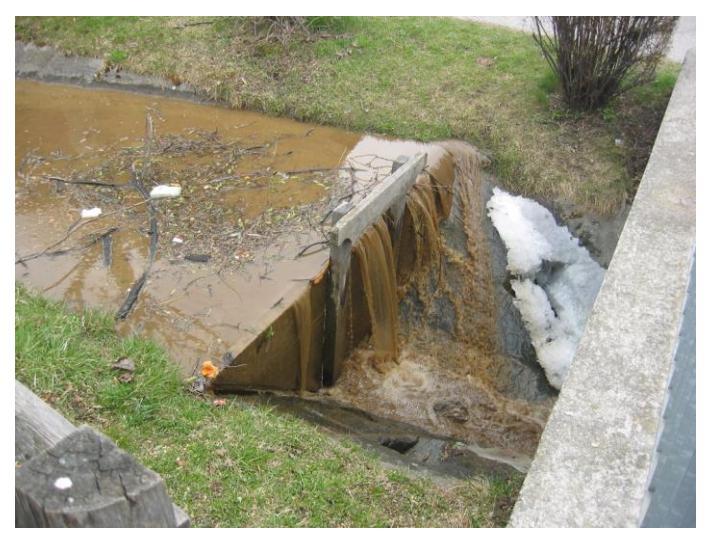
Damming, Rakes

Small amounts of debris can often be removed by the person who created the damming (obstacle).

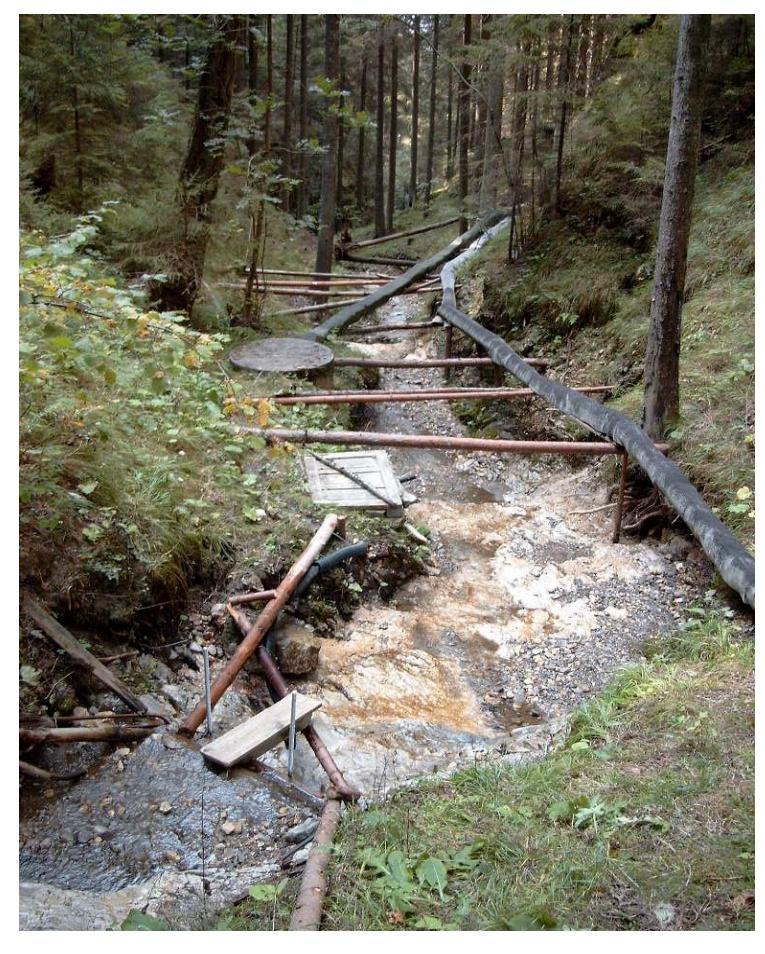
Water diversion, water discharge

Above all, direct and unprotected surface water discharged into embankments can have far-reaching consequences, such as triggering bank breaks, etc. Discharge pipes can be carried away and act like driftwood.

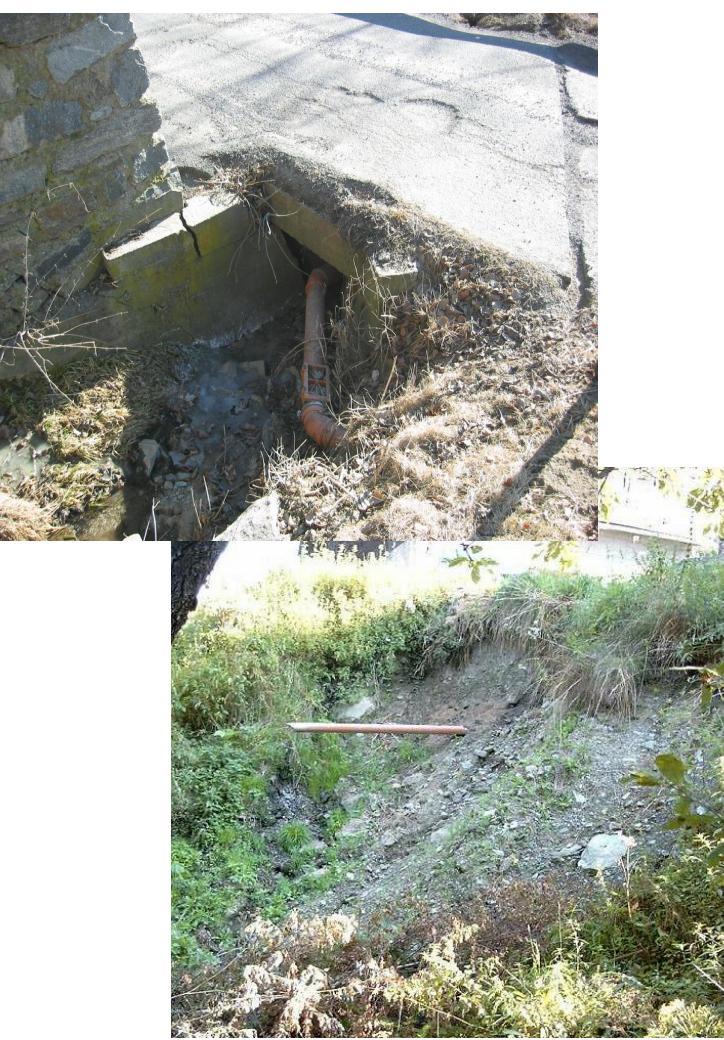
Water diversion, water discharge

Above all, direct and unprotected surface water discharged into embankments can have far-reaching consequences, such as triggering bank breaks, etc. Discharge pipes can be carried away

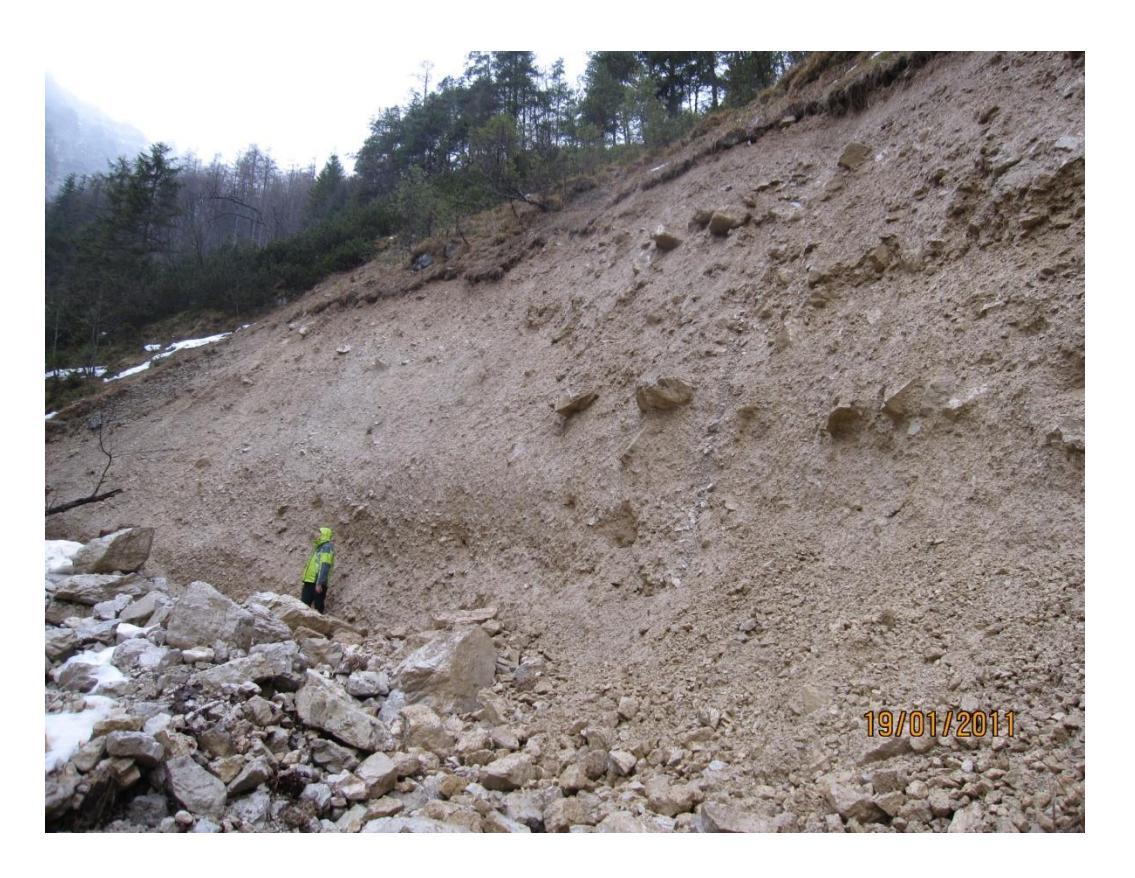
Bank rapures are a natural process in mountain torrents and **typical of mountain torrents**.

However, bank raptures in extremely unfavourable places or cracks that are noticeably **atypical** or particularly large for the individual mountain torrent must be documented and reported to the municipality.
