Critical conditions (flow obstacles) in torrents

DI Felix Schiestl DI Thomas Schaller

- Legal base in Austria
- Torrent inspection
- Riparian vegetation driftwood
- dangerous depositions

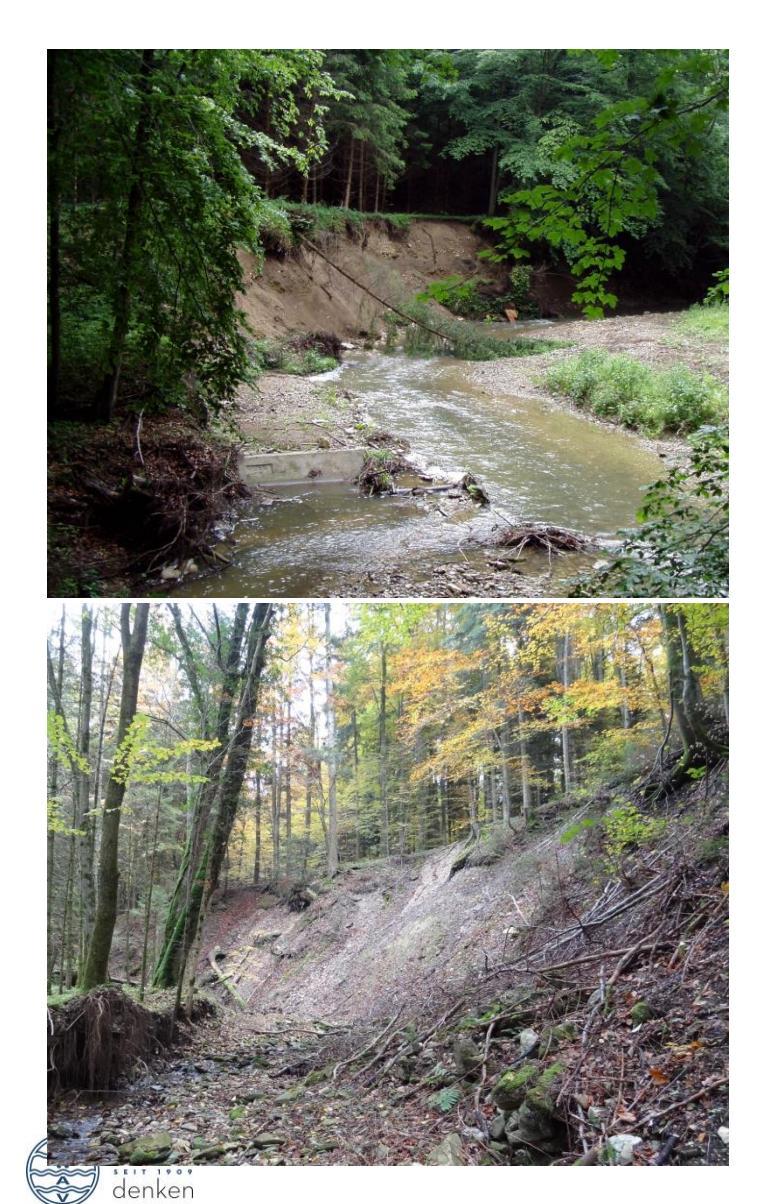
Pointed overloading of the bed load, as well as bed load impacts caused by large bank collapses, often lead to sedimentation with far-reaching consequences. A channel cross-section that is sufficiently large in and of itself can thus very quickly be overloaded, causing extensive damage. When it comes to slope failures, the cause of the landslide should be clarified (e.g. introduction of surface water, road drainage), as there may be a polluter here as well.
